# Implications from the Reunion Debris found July 29, 2015

Michael Exner

July 30, 2015

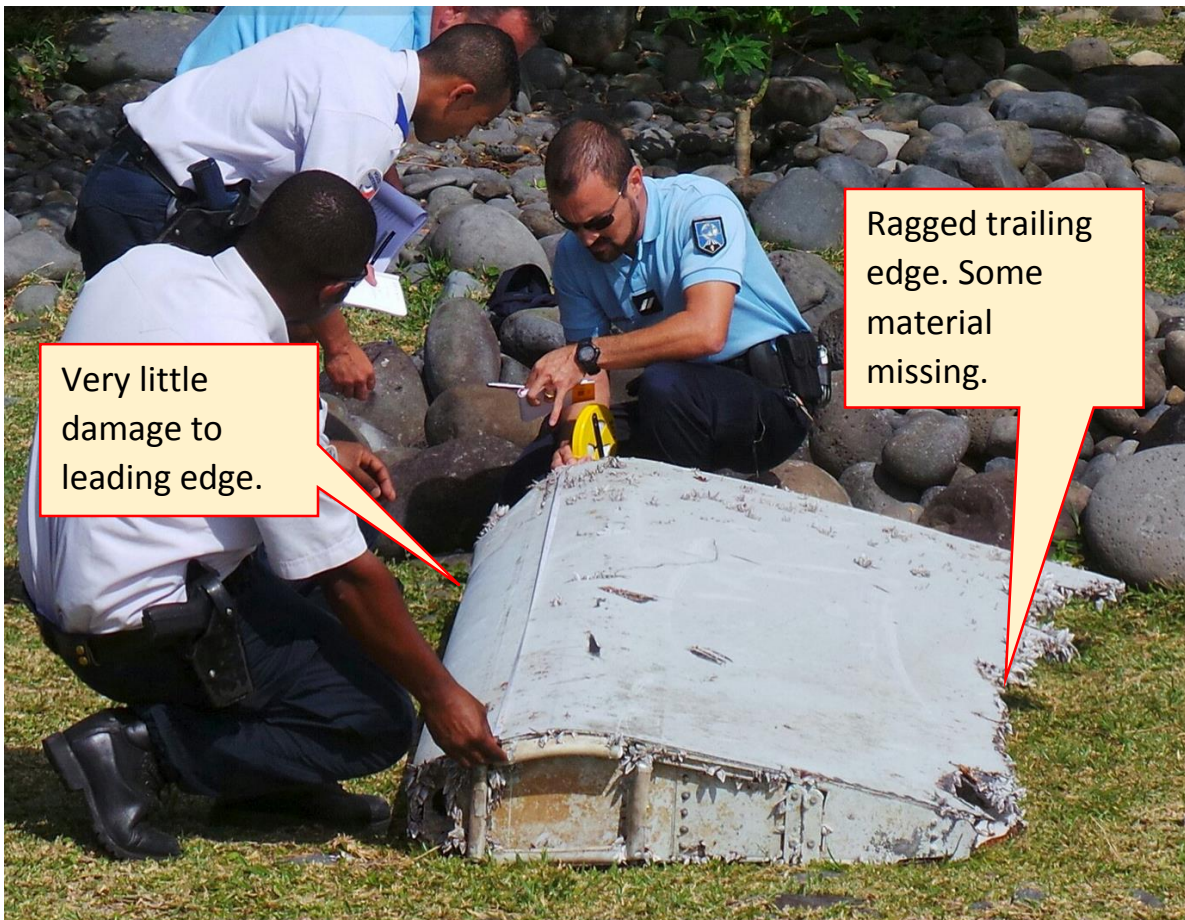
Debris found on Reunion Is. The shape, dimensions and P/Ns found on debris are consistent with a wing component from a B777 airplane, most likely the right “Flaperon” from MH370.

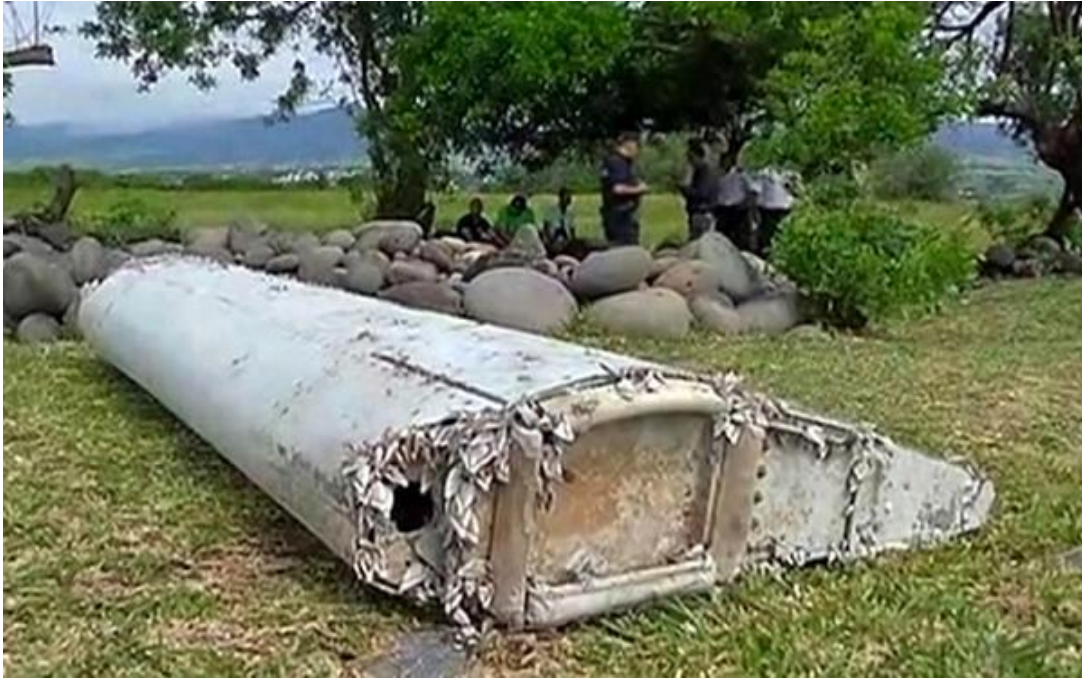
Left end of Right Flaperon (to be verified by serial number). Note lack of damage to leading edge.

However, the lack of leading edge damage points to the second scenario only. If the Flaperon was on the aircraft when the aircraft contacted the water, it is very likely that there would be some compression damage on the leading edge. But there is virtually no apparent compression damage. This is much more consistent with the Flaperon being “torn” from the wing while in high speed flight (forced rearward by the airflow). In addition, the ragged tear along the trailing edge is indicative of flutter induced stress and ultimate fatigue failure, not a break off due to high bending moments at impact.

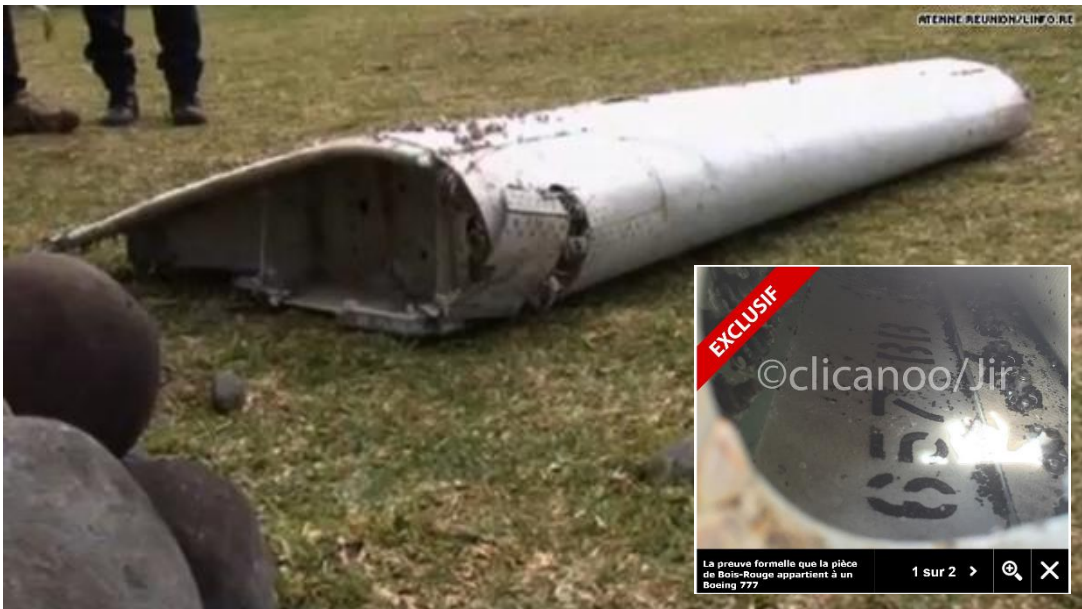
Right end of Right Flaperon (to be verified by serial number). Note actuator control horn has been torn away from the Flaperon.

If the Flaperon separated from the aircraft while still in flight, it indicates an in-flight breakup, most likely due to very high speeds, flutter and perhaps loss of hydraulic/electrical power to the Flaperon actuator post fuel exhaustion. This scenario is consistent with the steep, spiral descent observed in the B777-200 simulator. If the in-flight separation is confirmed, it would reduce the likelihood that the plane flew on any significant distance past the 7<sup>th</sup> ARC as some have speculated, and reinforce the theory that the POI is relatively close to the 7<sup>th</sup> ARC.

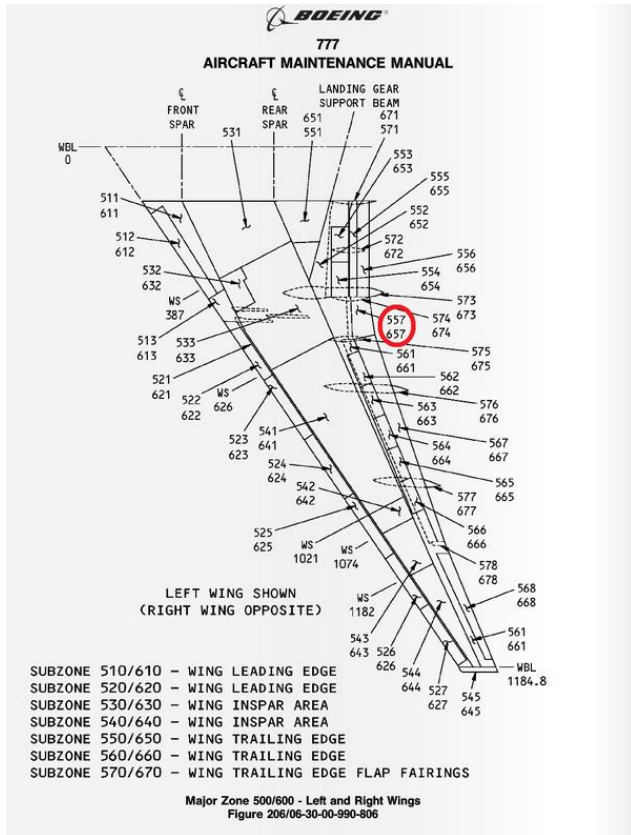
**777 AIRCRAFT MAINTENANCE MANUAL**

Boeing drawings and PN table indicate the number BB670 and 657BB (both have been reported) are consistent with the B777 wing.
